# Cedar Creek Burned Area Summary

## 2500-8 Burned Area Report

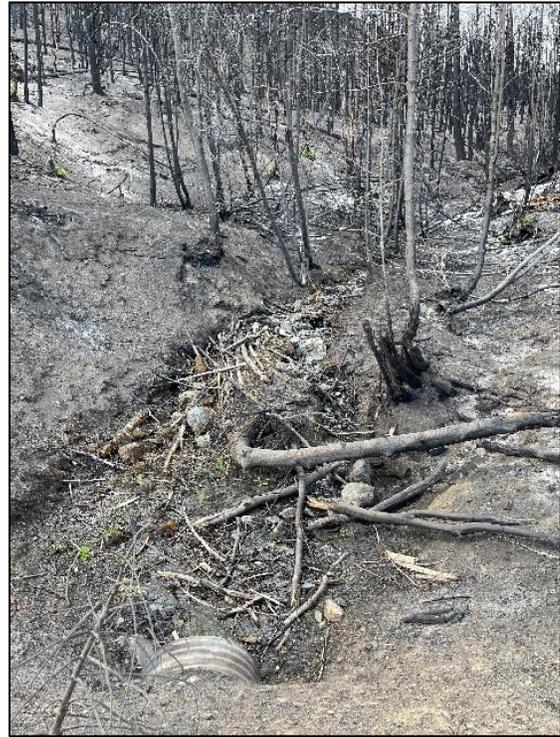
Watershed response will likely include an initial flush of ash and fine sediment, rill and gully erosion in headwater drainages and in small, steeper drainages within the burned area, debris-laden flash floods (Figure 2) and debris flows in response to high-intensity rain events, as well as elevated snowmelt peak flows.

Figure 2 Debris in burned channels is easily mobilized by rain and increased flows.

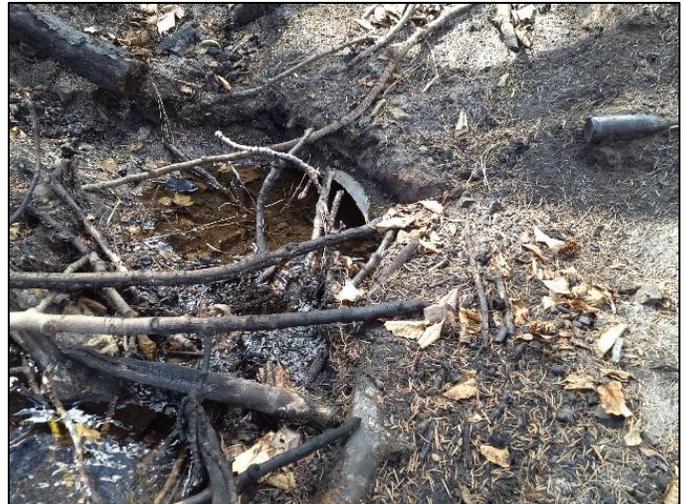
The watersheds burned in the Cedar Creek Fire are predicted to exhibit varying degrees of response through increased runoff, and debris and sediment transport. This creates a future concern for roads, culverts (Figure 3), bridges, and channels along the drainage paths of the burned watersheds in that they may be plugged, overtopped, or washed away more frequently than experienced under pre-fire conditions.

Figure 3 Burned debris can quickly plug undersized culverts.

The proposed treatments include signs warning travelers of the increased danger, construction of dips and armored dips to facilitate drainage, installation of drop inlets to ensure drainage functions remain intact with added debris, cut off damaged section of pipes to ensure free drainage, clean inlets, catch basins and outlets to restore functional drainage, and regular storm inspection and response.

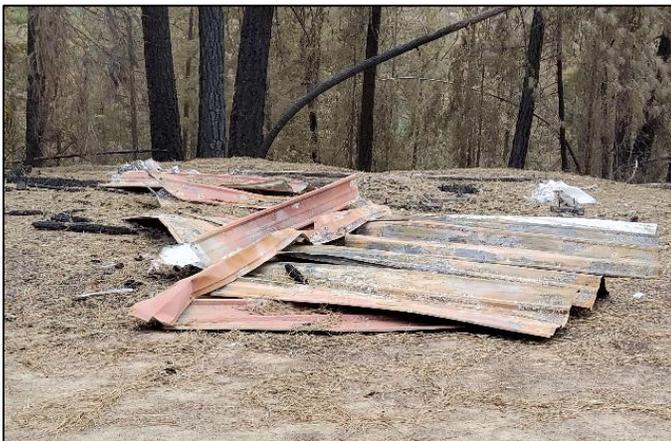
**Trailheads and Trails:** The Wolf Creek trailhead was burned over resulting in loss of infrastructure and the presence of hazard trees. Because the trailhead is a location for congregation of the public and administrative personnel, there is a high risk to life and safety due to the threat of overhead hazards from hazard trees. The toilet (Figure 4) burned leaving an open vault containing human waste, resulting in high risk to life and safety. Recommended treatments include temporary closure of the trailhead and treating or pumping the toilet and sealing the open holes to prevent them from filling with water and snow.

Figure 4 All that remains of the Wolf Creek TH toilet is the metal roof.

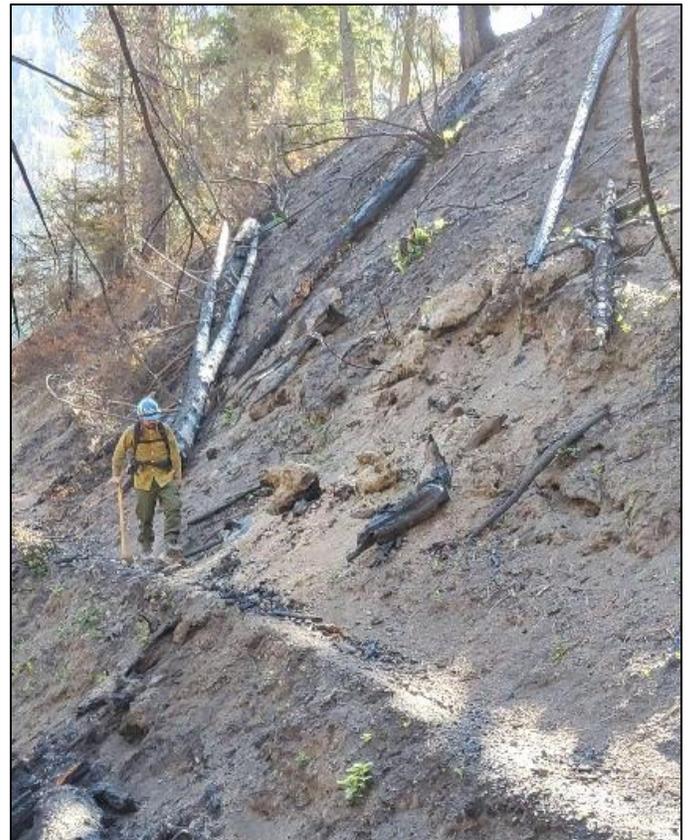
The Cedar Creek trail (476 – Figure 5), Wolf Creek

trail (527), and some trails in the Chickadee area, including Thompson Ridge trail, experienced moderate to high burn severity. These trails are high or medium use trails that were in good condition prior to the fire. Due to post fire threats, these trails have a very high level of risk for infrastructure damage or failure. These trails are recommended for treatment to stabilize, stormproof, or mitigate the anticipated impact of post-fire storm events.

Figure 5 Cedar Creek Trail damage may get worse with eroding hillslopes.

Additional recommended treatment includes temporary closure of the Cedar Creek trail (476), Wolf Creek trail (527), and some trails in the Chickadee area, including portions of the Thompson Ridge trail. These are the highest use and most impacted trails.

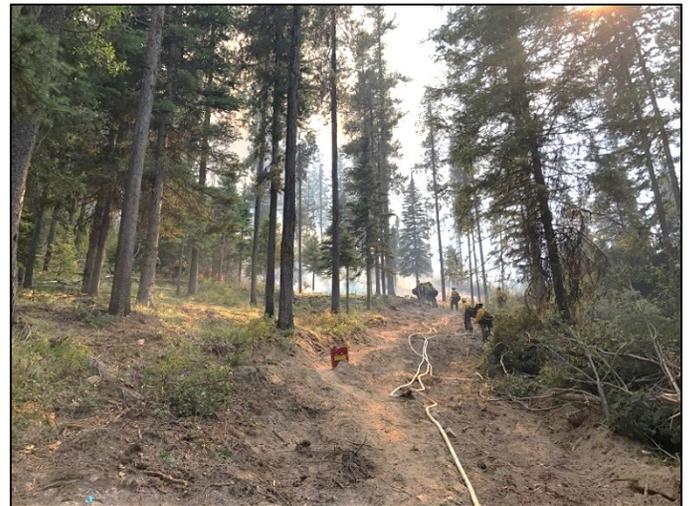
Approximately 43 miles of dozer line and 8 miles of handline (Figure 6) were constructed outside and within the burn perimeter. In addition to

causing an increase in weed invasion, the disturbances caused by dozer lines are expected to create accelerated erosion and soil compaction that may also inhibit the recovery of native plant populations. The Cedar Creek fire overlapped with five different fires that have occurred on USFS land within the past 35 years. It is expected that 109 acres of shrub steppe communities, and 23,215 acres of dry and hot forested plant communities that reburned within the past 35 years will face impacts given the invasion of cheatgrass, knapweed, dalmatian toadflax and whitetop that are changing the ecological response and fire resiliency of these ecosystems. It is also expected that the 10 acres of riparian communities that burned at moderate to high severity are vulnerable to establishment of noxious weeds from off forest wind dispersed species. If weed infestations are not detected and controlled within the first year post-fire, these previously intact native communities will likely type-convert into exotic species dominance.

Figure 6 Newly dug firelines are good host locations for invasive weeds.

The Forest recommends a treatment of Early Detection, Rapid Response (EDRR) to monitor for noxious weed infestation and expansion. In areas disturbed due to mechanical suppression activity (approximately 360 acres) and burned areas prone to new noxious weed infestations (120 acres), weed technicians will perform regular surveys and treat new infestations.

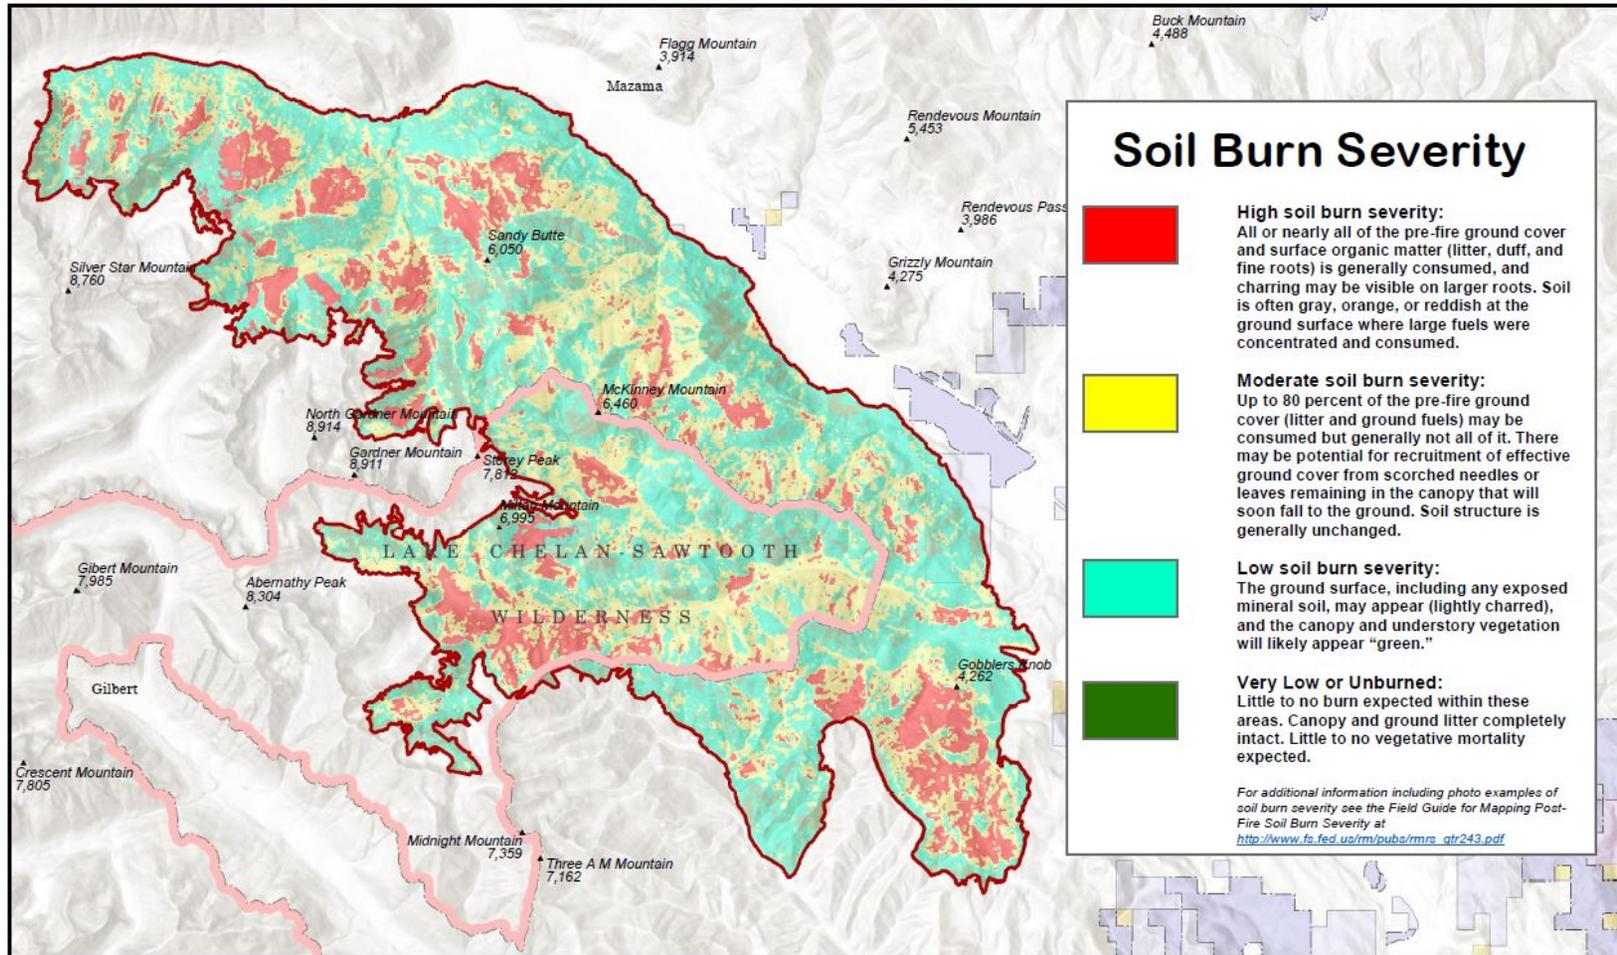
Figure 7 Soil burn severity map of the Cedar Creek Fire.

An estimated 48% of the burned area within the Cedar Creek Fire exhibit high or moderate soil burn severity and may have developed water repellent soils as a result (see map on page 7). Like the Cub Creek 2 Fire, vegetation mortality in the moderate and high soil burn severity areas ranged from 80 – 100%.

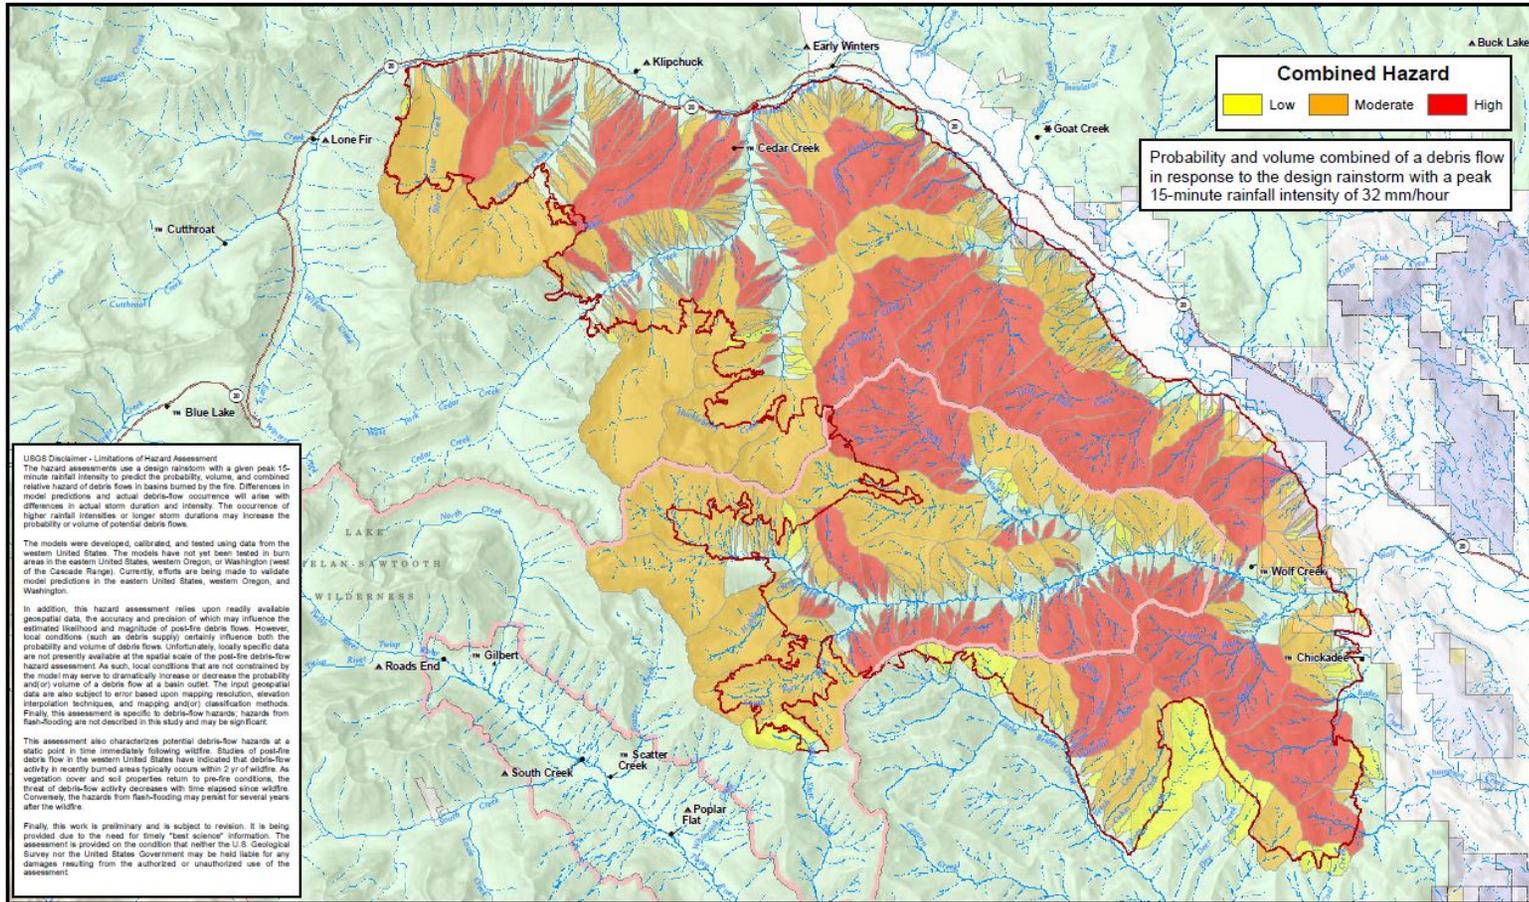
Figure 8 Debris flow hazards for the Cedar Creek Fire

A storm event of 32 mm/h (about 0.3 inches in 15 minutes) was predicted to have greater than 80% probability of debris flows in several drainages, including but not limited to many of the tributaries to Wolf Creek, several tributaries to the Methow River, several tributaries to Early Winters Creek, and two tributaries to Little Bridge Creek in the Twisp River drainage.

The probability of debris flows is even higher in the Cedar Creek burned area in response to a 15-minute intensity of 40 mm/h (about 0.4 inches in 15 minutes), a rain event with roughly a 10-year recurrence interval.

Most of these watersheds are roughly estimated to produce more than 1,000 m<sup>3</sup> of debris, resulting in a high debris flow hazard.

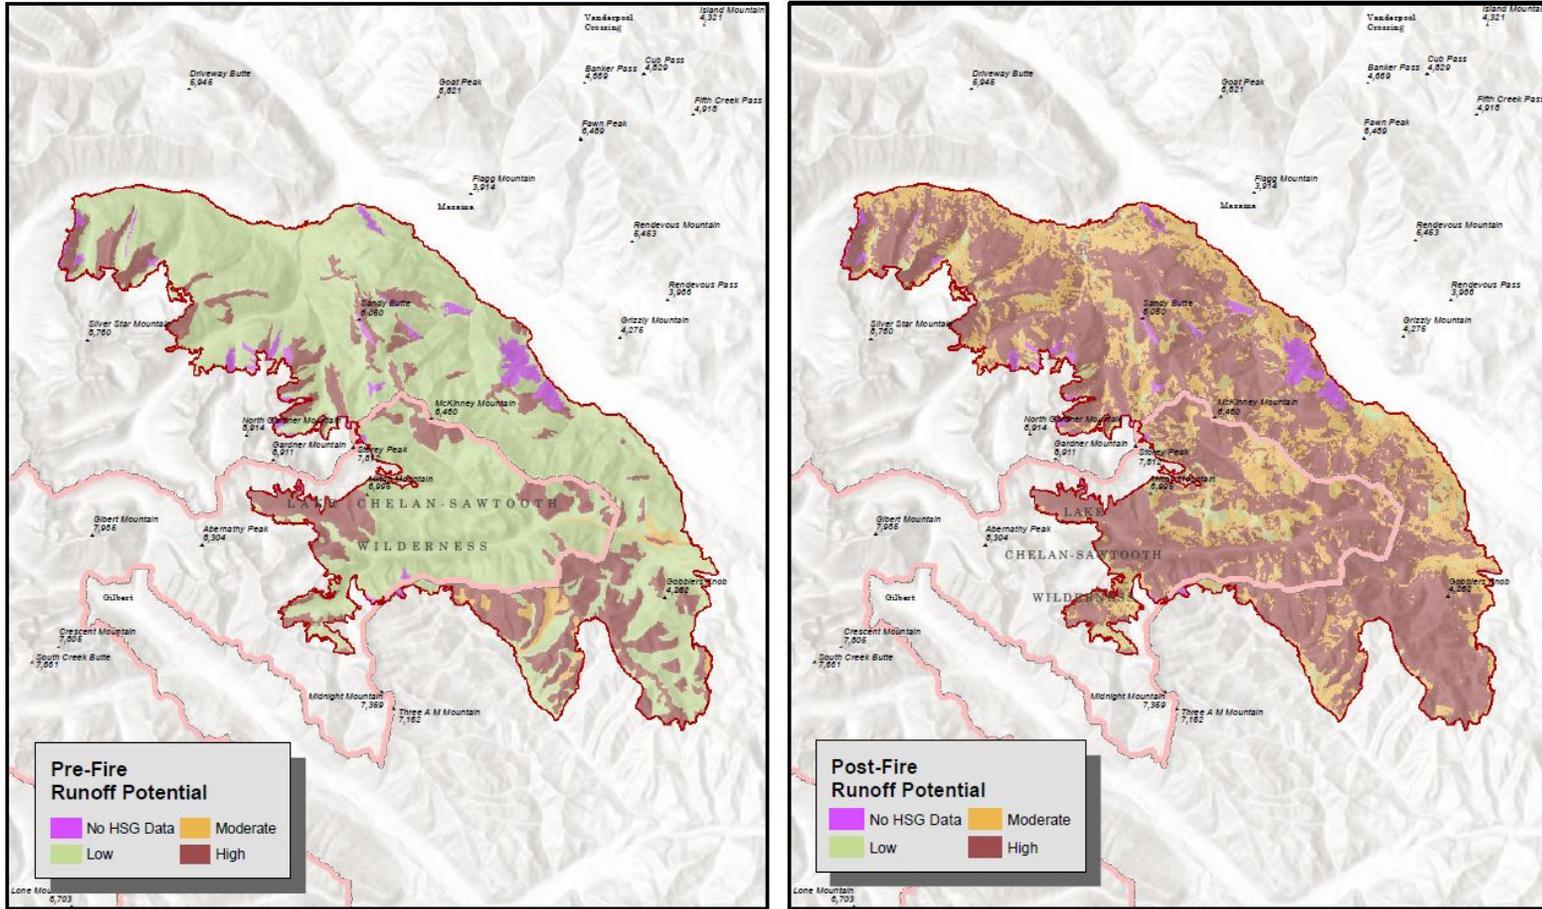
Figure 9 Maps showing pre- and post-fire modeled runoff potential.

Preliminary hydrologic modeling indicates flow increases in many headwater channels of >100x the pre-fire flow rates for a given storm. Water quality

will be diminished during seasonal peak runoff, as well as after high-intensity summer rains, due to elevated ash, fine sediment, and nutrient loading. Elevated post-fire response will gradually diminish over time as vegetation and groundcover levels recover over the next several years, although some impacts are likely to persist for a decade or longer (see map on page 9).

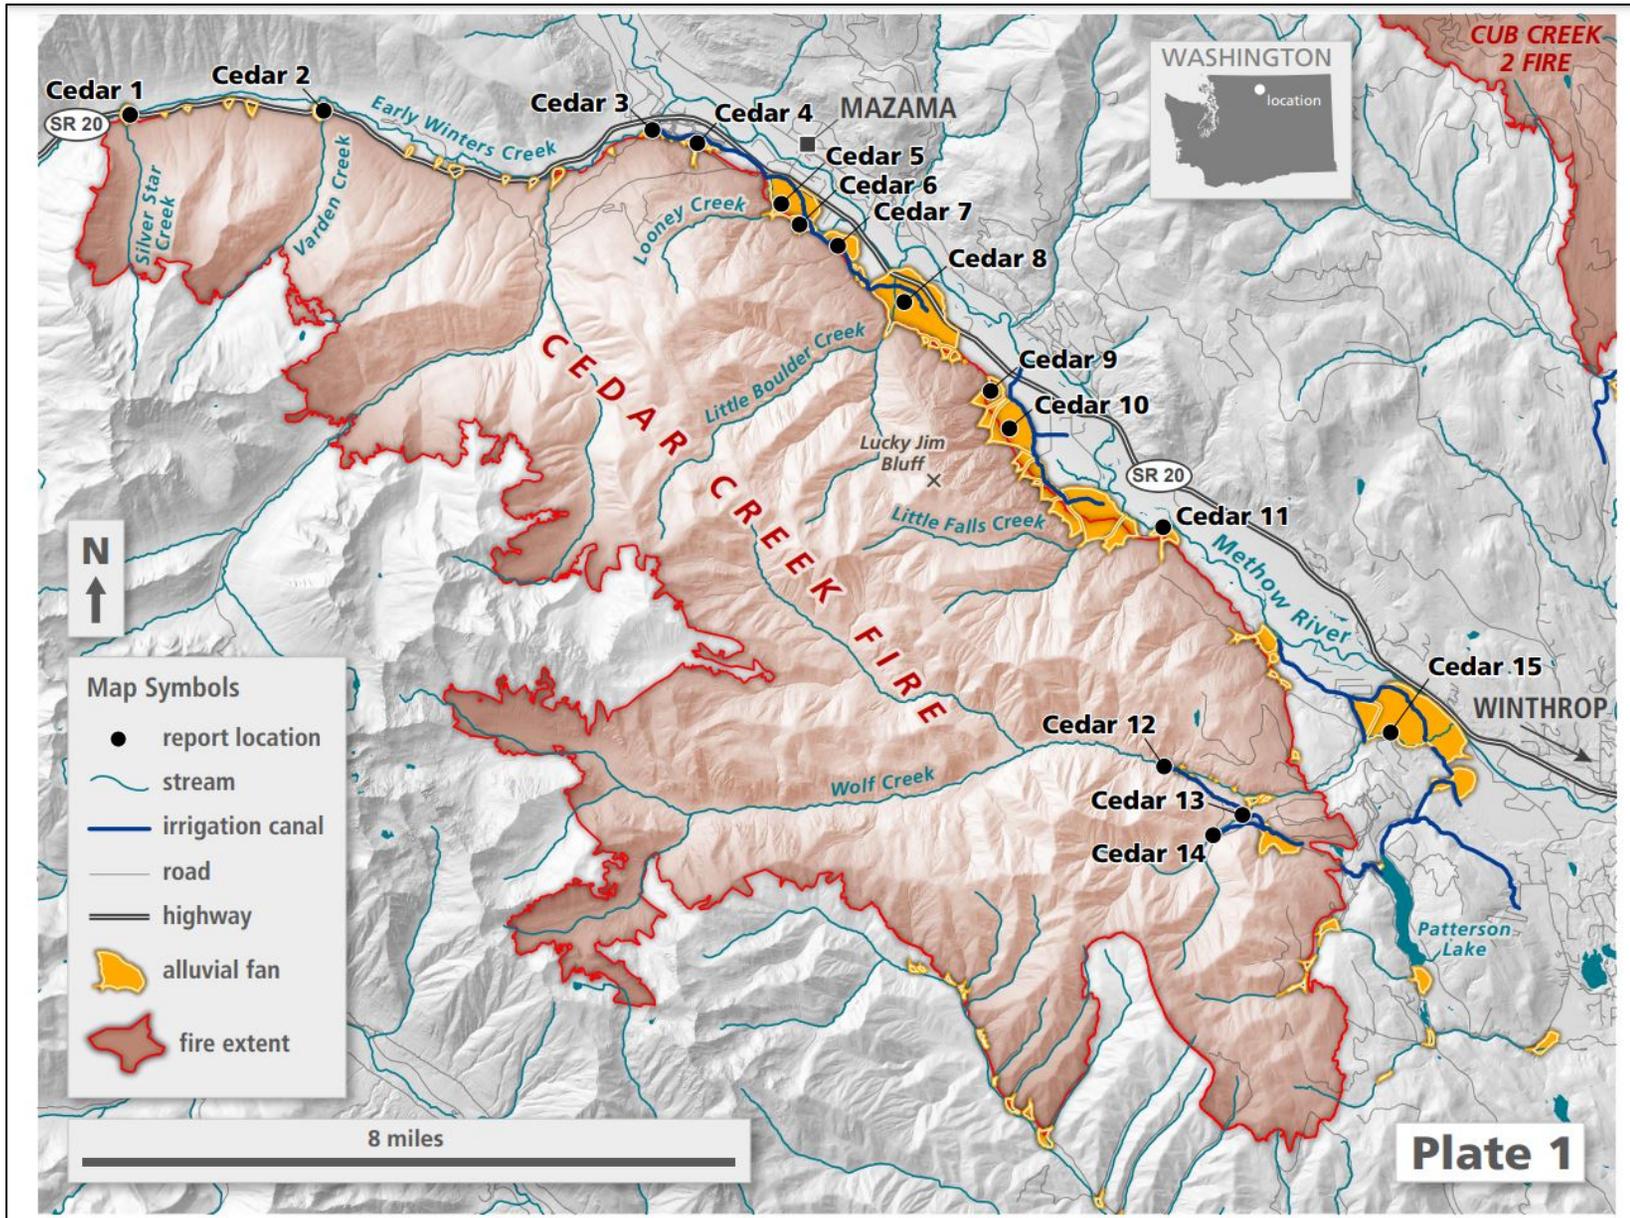
Figure 10 Map of alluvial fans in the vicinity of the Cedar Creek Fire.

Non-FS values within and downstream of the burned area may also be threatened by inundation from flooding and debris flows, including but not limited to homes on debris fans along the northeast face of the fire, homes on the Wolf Creek debris fan and on fans south of Wolf Creek, and State Highway 20 (see map on page 8). The Washington Geological Survey's full Wildfire-Associated Landslide Emergency Response Team Report (WALERT) can be found at [https://www.dnr.wa.gov/publications/ger\\_hazards\\_landslide\\_walert\\_report\\_cedar\\_cub\\_2021.pdf](https://www.dnr.wa.gov/publications/ger_hazards_landslide_walert_report_cedar_cub_2021.pdf). A map showing alluvial fans on the edge of the fire perimeter from their report is duplicated on page 10 of this summary.
