# Twentyfive Mile Fire Burned Area Summary

## 2500-8 Burned Area Report

# Burn Severity - Twenty-Five Mile Fire

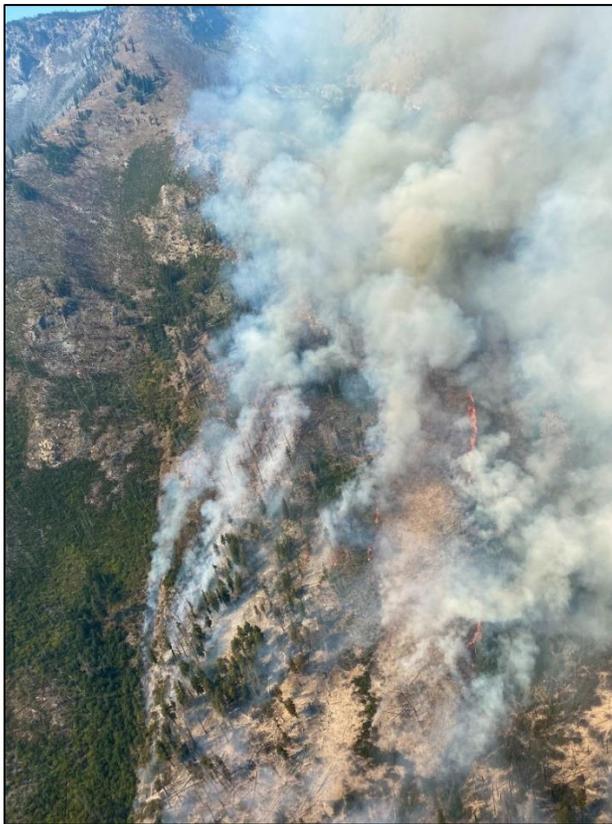
Figure 1 Fire activity within the Twentyfive Mile Fire.

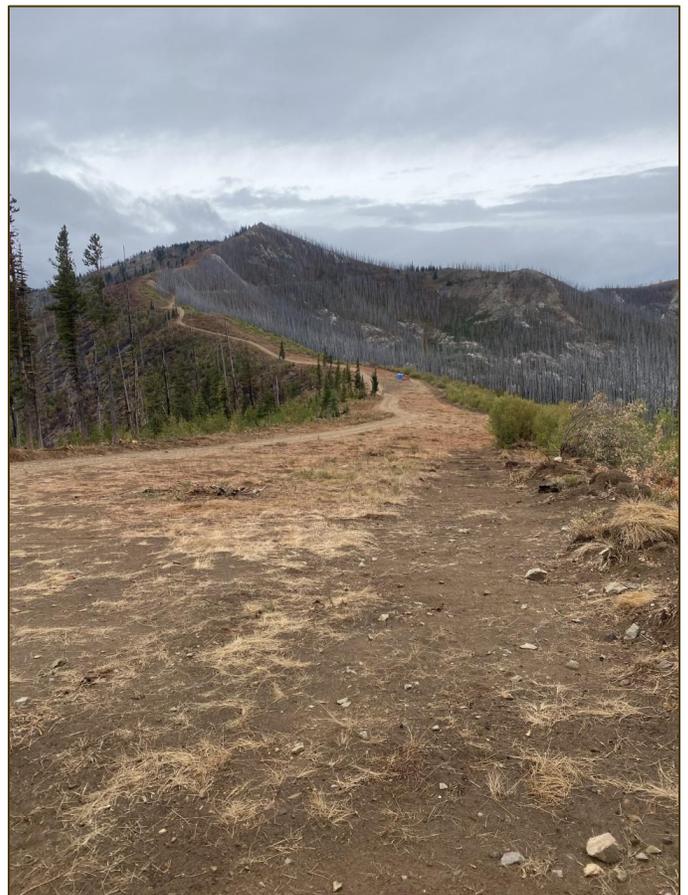
Approximately 15 miles of dozer line (figure 5) and 7 miles of handline were constructed outside and within the burn perimeter. In addition to causing an increase in weed invasion, the disturbances caused by dozer lines are expected to create accelerated erosion and soil compaction that may also inhibit the recovery of native plant populations.

Figure 5 Dozer suppression lines are hot spots for invasive weeds.

The Forest recommends a treatment of Early Detection, Rapid Response (EDRR) to monitor for noxious weed infestation and expansion. In areas disturbed due to mechanical suppression activity (approximately 88 acres) and burned areas prone to new noxious weed infestations (230 acres), weed technicians will perform regular surveys and treat new infestations.

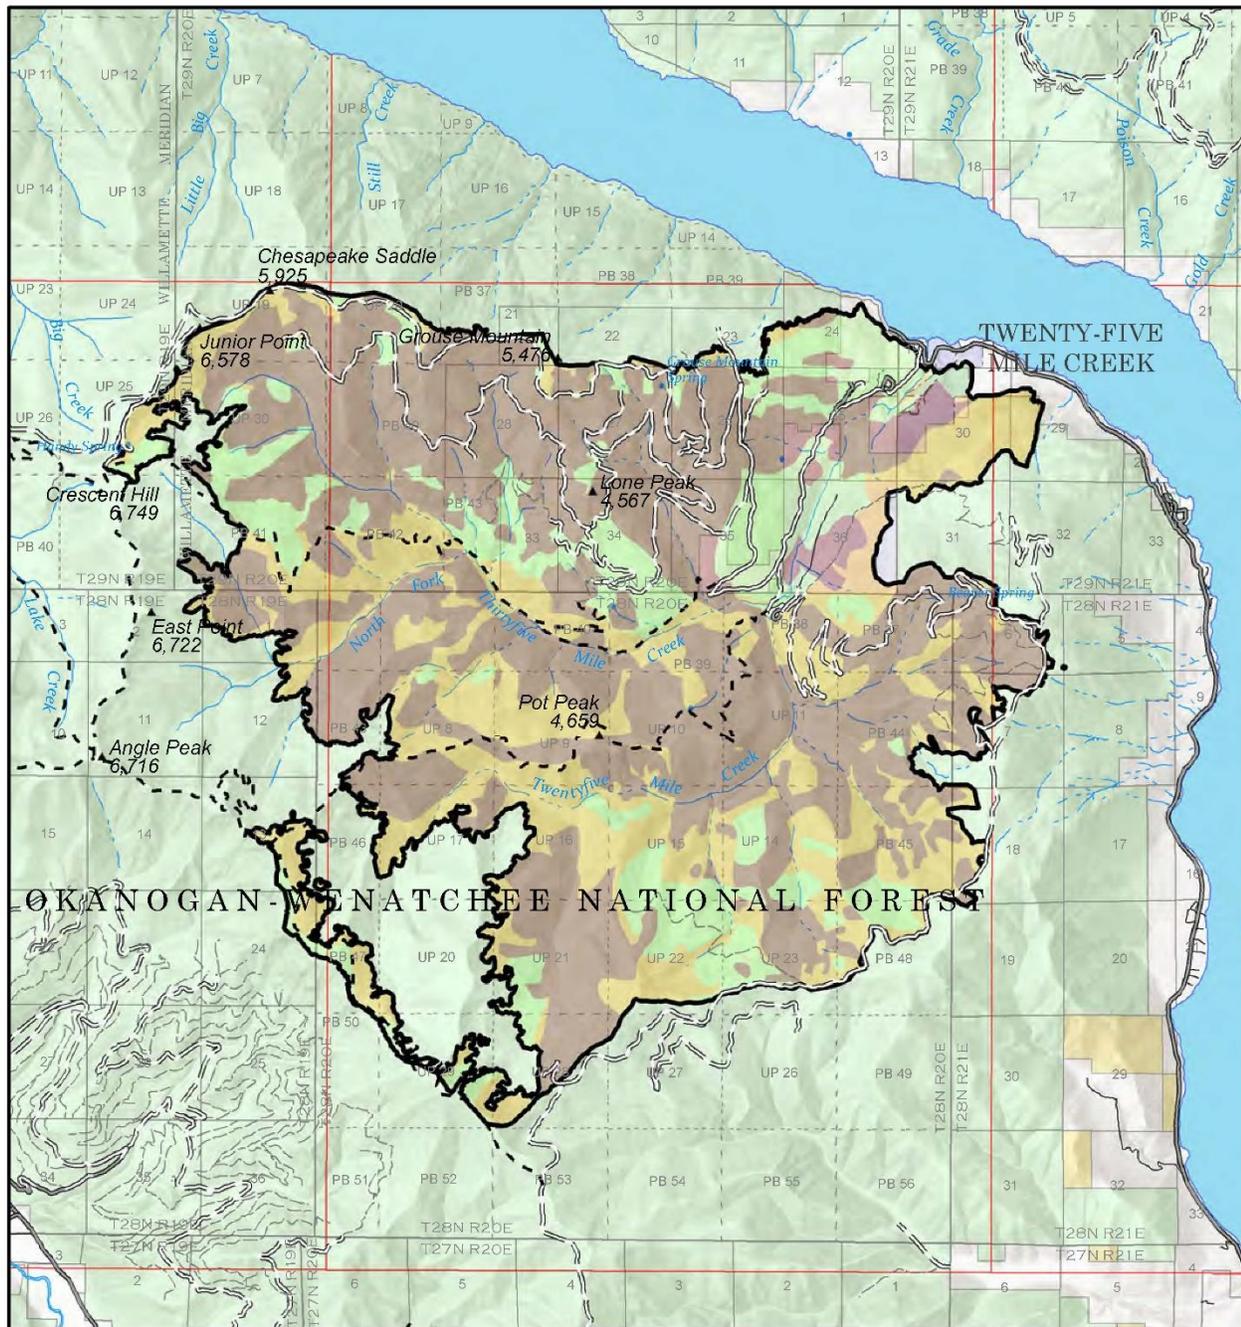
# Runoff Potential - Twenty-Five Mile Fire

Figure 9 Post-fire modeled runoff potential.
