Schneider Springs Fire Burned Area Summary

2500-8 Burned Area Report

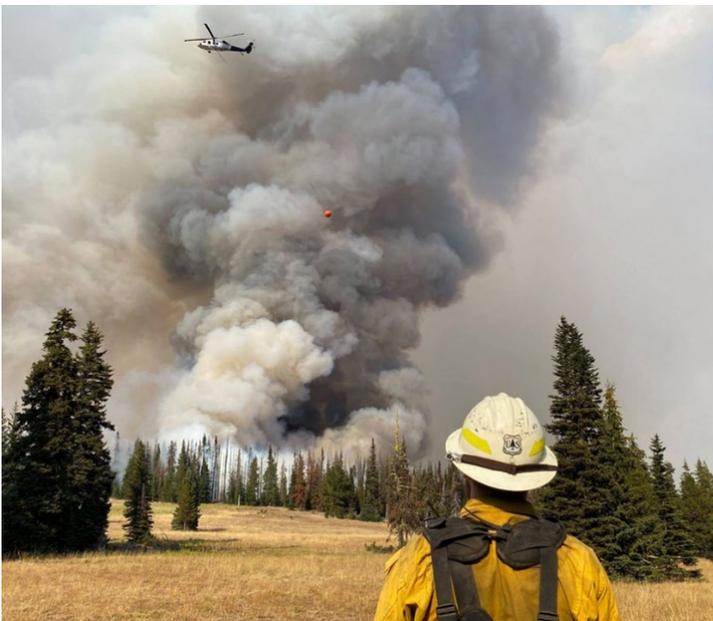
Figure 1 Fire activity within the Schneider Springs Fire on the southside of FS Road 199 (8/29/21)

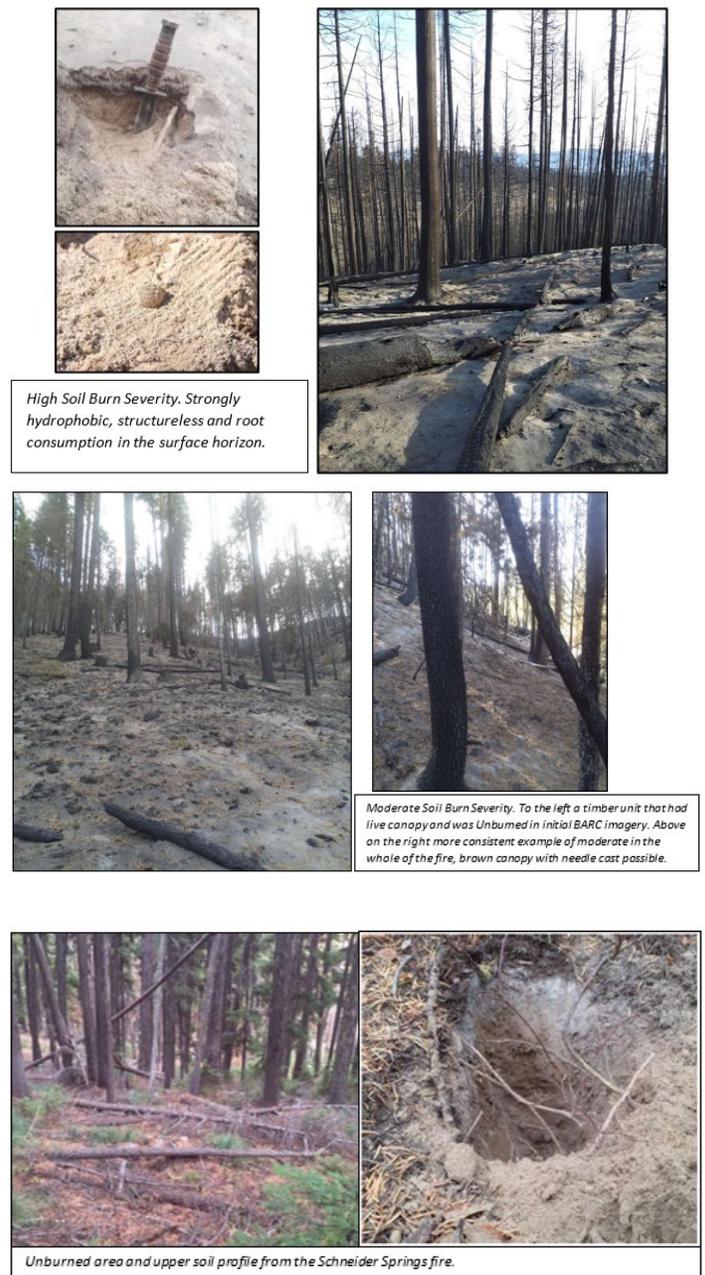
Soils within the Schneider Springs fire boundary are generally weakly developed, well drained, volcanic ash capped soils on steep (30-60%) to very steep (>60%) slopes. Field reconnaissance (figure 2) showed that areas with high soil burn severity (SBS) existed in areas where forest canopy was completely consumed. Areas of moderate SBS generally had some woody material left on the surface, complete or nearly complete litter and duff consumption, and browning needles in the canopy.

Figure 2 Ground observations of high, moderate and low burn severity conditions.

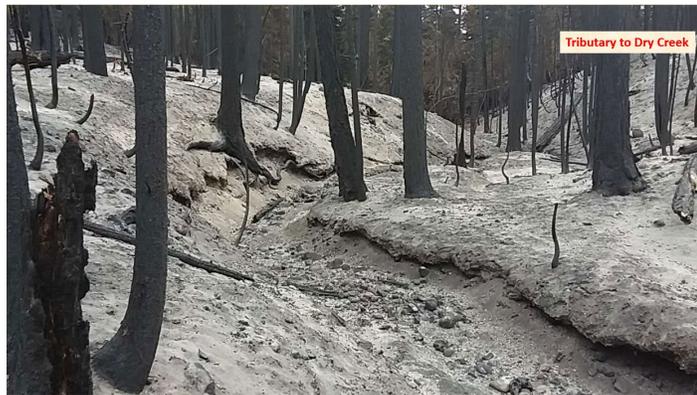
A lack of canopy cover and an abundance of water repellent conditions mean splash erosion will increase dramatically and limited areas of effective ground cover erosion and runoff will increase dramatically. Initial intense rainfall events will transport ash and initiate runoff that will mobilize

and transport bedload and debris disproportional to the amount of flow. Analysis of pre- and post-fire streamflow in several representative watersheds that drain into the Naches River show that small tributaries in the Lower Bumping River, Lower American River, Lost Creek, Nile Creek, Upper, Lower and Little Rattlesnake, Twenty-Five Mile Creek which would not have any projected flows from a 5 yr. / one hour rainfall event could produce flows that will measure in the 100's of cubic feet per second (cfs) (see map on page 8). Over time, as ground cover and canopy cover increase and water repellency decreases, runoff response and soil detachment and sediment transport will decrease. In areas that have reburned and are now classified as high burn severity, this process may take years.

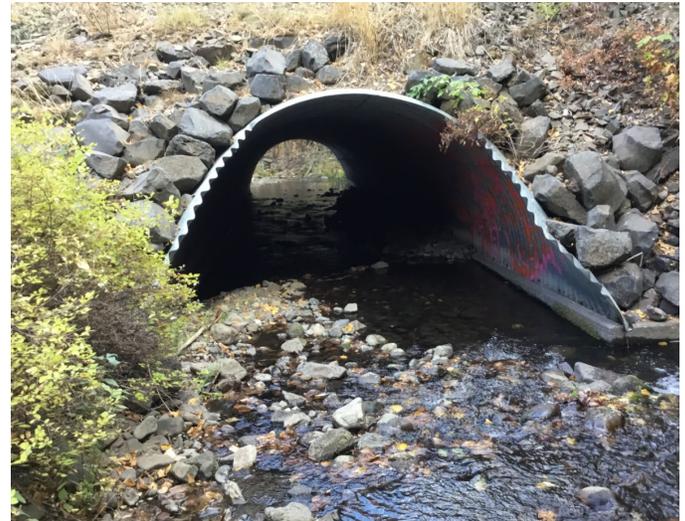
The watersheds burned in the Schneider Springs Fire are predicted to exhibit varying degrees of response through increased runoff, and debris and sediment transport. This creates a future concern for roads, culverts (figure 3), bridges, and channels along the drainage paths of the burned watersheds in that they may be plugged, overtopped, or washed away more frequently than experienced under pre-fire conditions.

Figure 3 Engineers and hydrologists evaluate culverts like this one to evaluate its capacity to handle the predicted increased flows in Nile Creek.

Forest Service System Roads and drainage features downstream of moderately and high burned areas are at an elevated risk of increased flow and debris from flash flooding. Specific roads, their maintenance level (see link for definitions), <https://www.fs.fed.us/eng/pubs/pdf/05771205.pdf> and proposed treatments are listed below.

Road #	Proposed Treatment
1500 Bethel Ridge	warning signs, additional drainage dips, storm proofing, storm inspection and response, material removal
1506-Three Creeks	clean culvert/catch basin, additional drainage dips, storm inspection and response
1600-Nile Loop	warning signs, clean culvert/catch basin, berm removal, drainage dips, storm inspection and response

1605-Clover Way	Warning, signs, clean culvert/catch basin, drainage dips, storm inspection and response, riser pipes installed, check dam, material removal
1607-Lost Creek	Storm inspection and response
1611-Orr Creek	culvert/catch basin, drainage dips, storm inspection and response, riser pipes, material removal
1617-Orr Ridge	culvert/catch basin, drainage dips
1631-Thirsty Way	storm proofing, drainage dips
1671-Lost Basin	Storm inspection and response
1802-Chipmunk Way	Warning signs, drainage dips
1605227-Glass Ridge	culvert/catch basin, drainage dips, storm inspection and response, riser pipes
1617260-Orr Way	Armored water bars
1601-Nile	Storm inspection and response with heavy equipment to protect stream crossing, culvert reported as bridge (CRAB)
1644-Nile	Storm inspection and response with heavy equipment to protect arch culvert
1502-Rattlesnake Bridge	Storm inspection and response at with heavy equipment to protect bridge

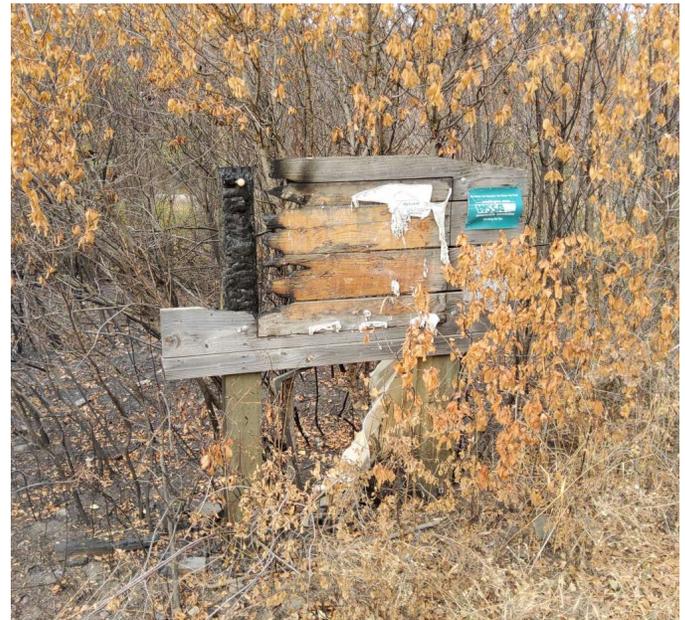
Figure 4 This burned sno-park trailhead sign is indicative of the passing fire.

In addition to trail-specific treatments, the BAER team recommends the removal of “danger trees” (fire-killed trees) in areas where crews will be working to implement identified treatments. The team also recommends the placement of warning signs at 156 trailheads, dispersed sites, campgrounds, wilderness sites and or logical ingress points to the burned area (figure 4). Finally,

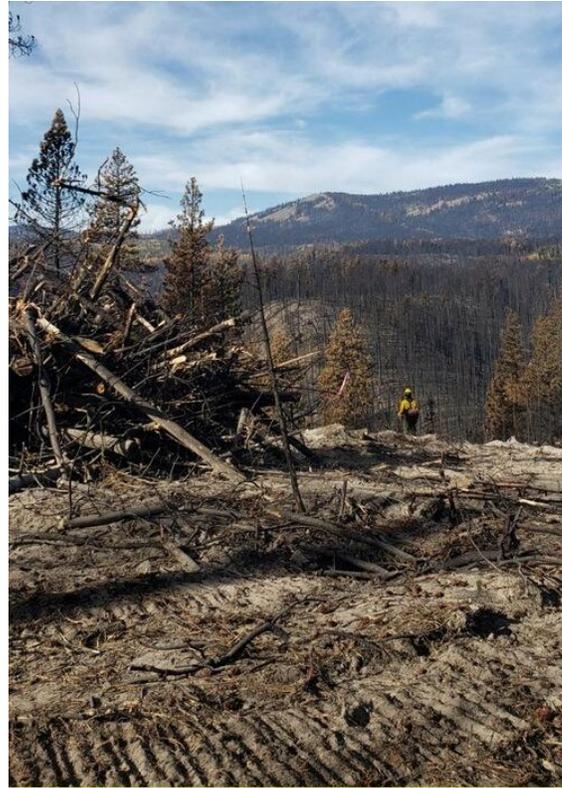
Approximately 291 acres were disturbed by fire suppression activities including dozer line, drop points, staging areas and landings (figure 5) with interior areas being largely un-infested. In addition to causing an increase in weed invasion, the disturbances caused by dozer lines are expected to create accelerated erosion and soil compaction that may also inhibit the recovery of native plant populations.

Figure 5 Dozer suppression lines are hot spots for invasive weeds.

The Forest recommends a treatment of Early Detection, Rapid Response (EDRR) to monitor for noxious weed infestation and expansion. In areas disturbed due to mechanical suppression activity and burned areas prone to new noxious weed

infestations weed technicians will perform regular surveys and treat new infestations.

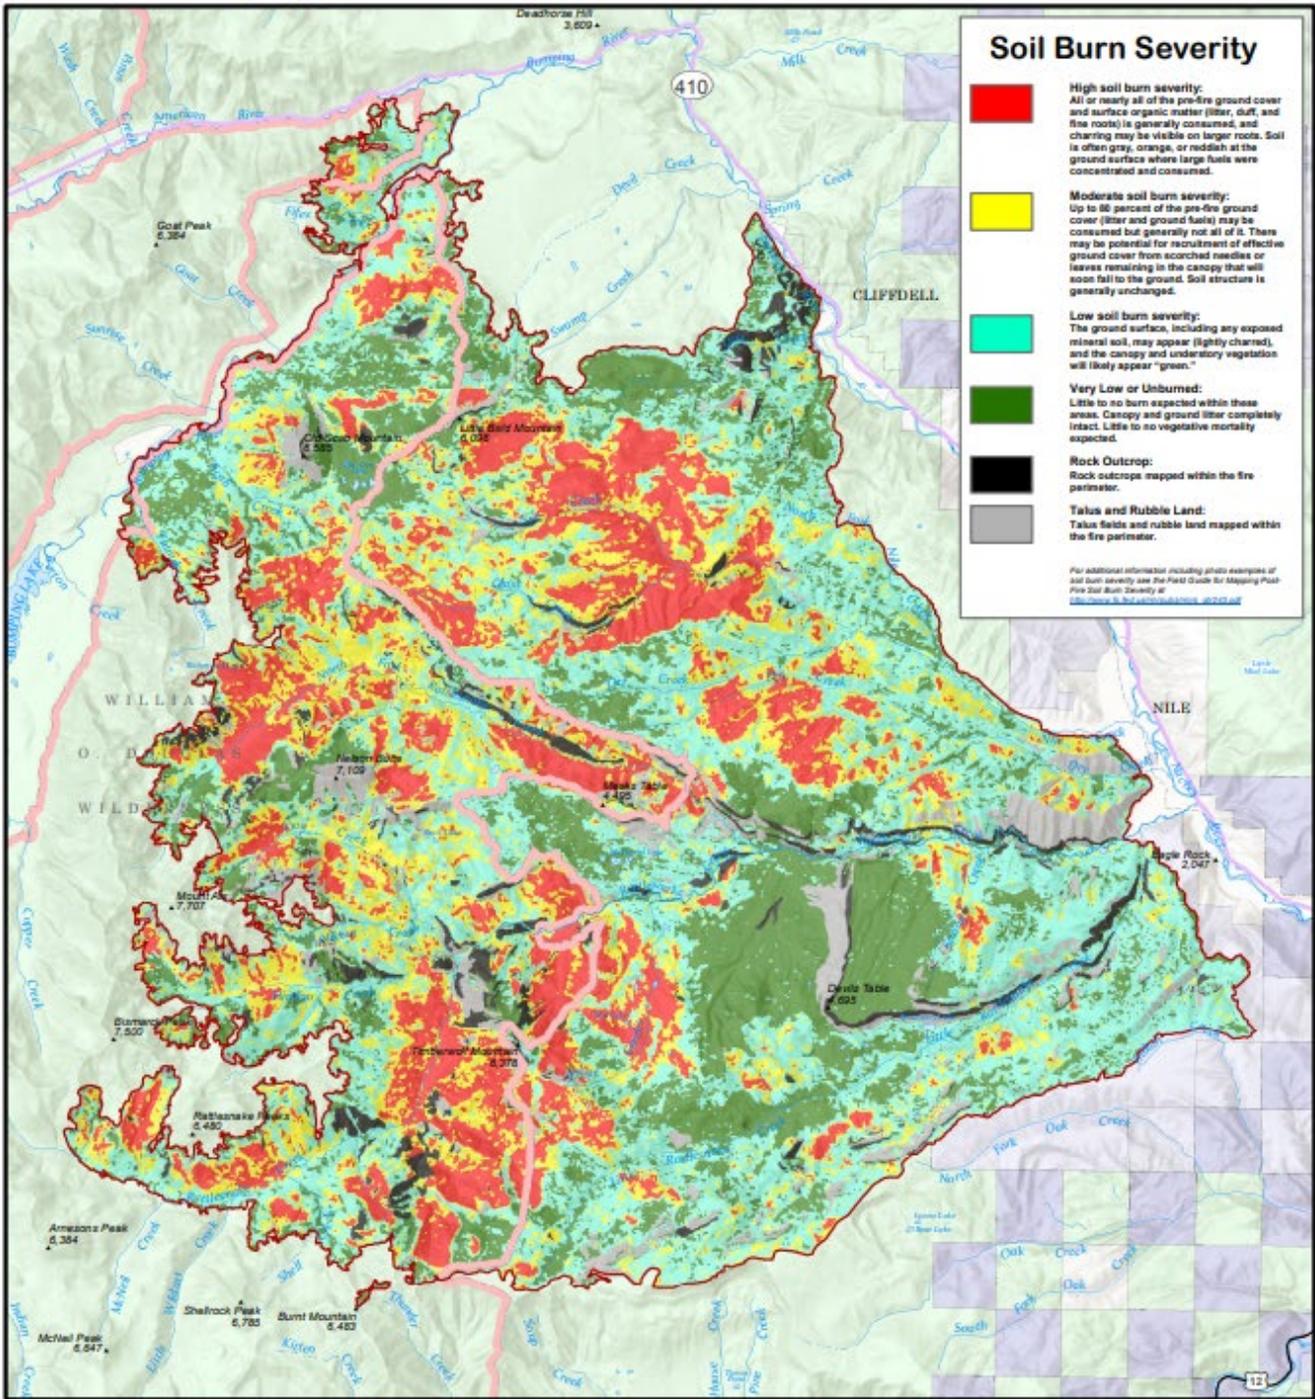
Soil Burn Severity Map - Schneider Springs Fire

Field validation of SBS for the fire mapped out as High (17%), Moderate (19%), Low (35%), Rock/ Outcrop, Talus and Rubble Lands (10%), and Unburned (21%) (see Figure 7); the assessment identified areas of water repellent conditions in the moderate and high SBS.

- High soil burn severity:**
All or nearly all of the pre-fire ground cover and surface organic matter (litter, duff, and fine roots) is generally consumed, and charring may be visible on larger roots. Soil is often gray, orange, or reddish at the ground surface where large fuels were concentrated and consumed.

- Moderate soil burn severity:**
Up to 60 percent of the pre-fire ground cover (litter and ground fuels) may be consumed but generally not all of it. There may be potential for recruitment of effective ground cover from scorched needles or leaves remaining in the canopy that will soon fall to the ground. Soil structure is generally unchanged.

- Low soil burn severity:**
The ground surface, including any exposed mineral soil, may appear (lightly charred), and the canopy and underlying vegetation will likely appear "green."

Figure 7 Burn severity map of the Schneider Springs Fire.

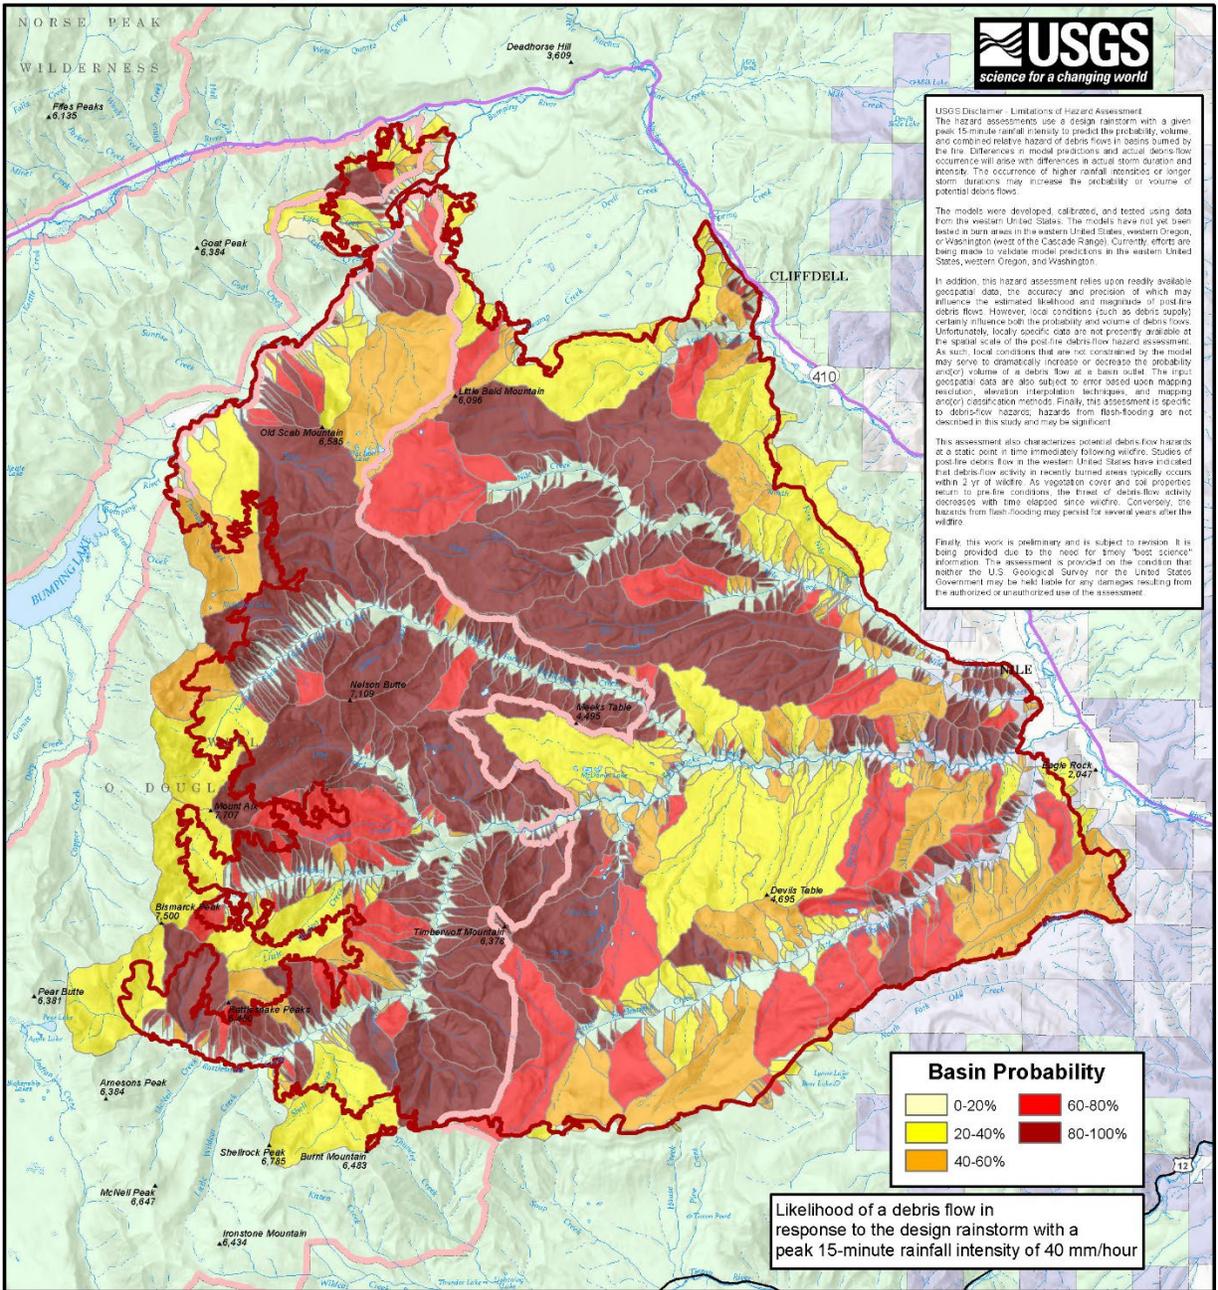
USGS Debris Flow Hazard Probability - 15 minute Intensity of 40 mm/h

The USGS-derived models estimate a moderate to high level of debris-flow hazard for most of the area burned by the Schneider Springs fire. When modeled against a 15 min / 40mm/hour storm (approximately 0.35" rain in 15 minutes), most large basins within the burned area have a high debris flow hazard rating and may experience debris flows (see Figure 8).

Figure 8 Debris flow hazards for the Schneider Springs Fire

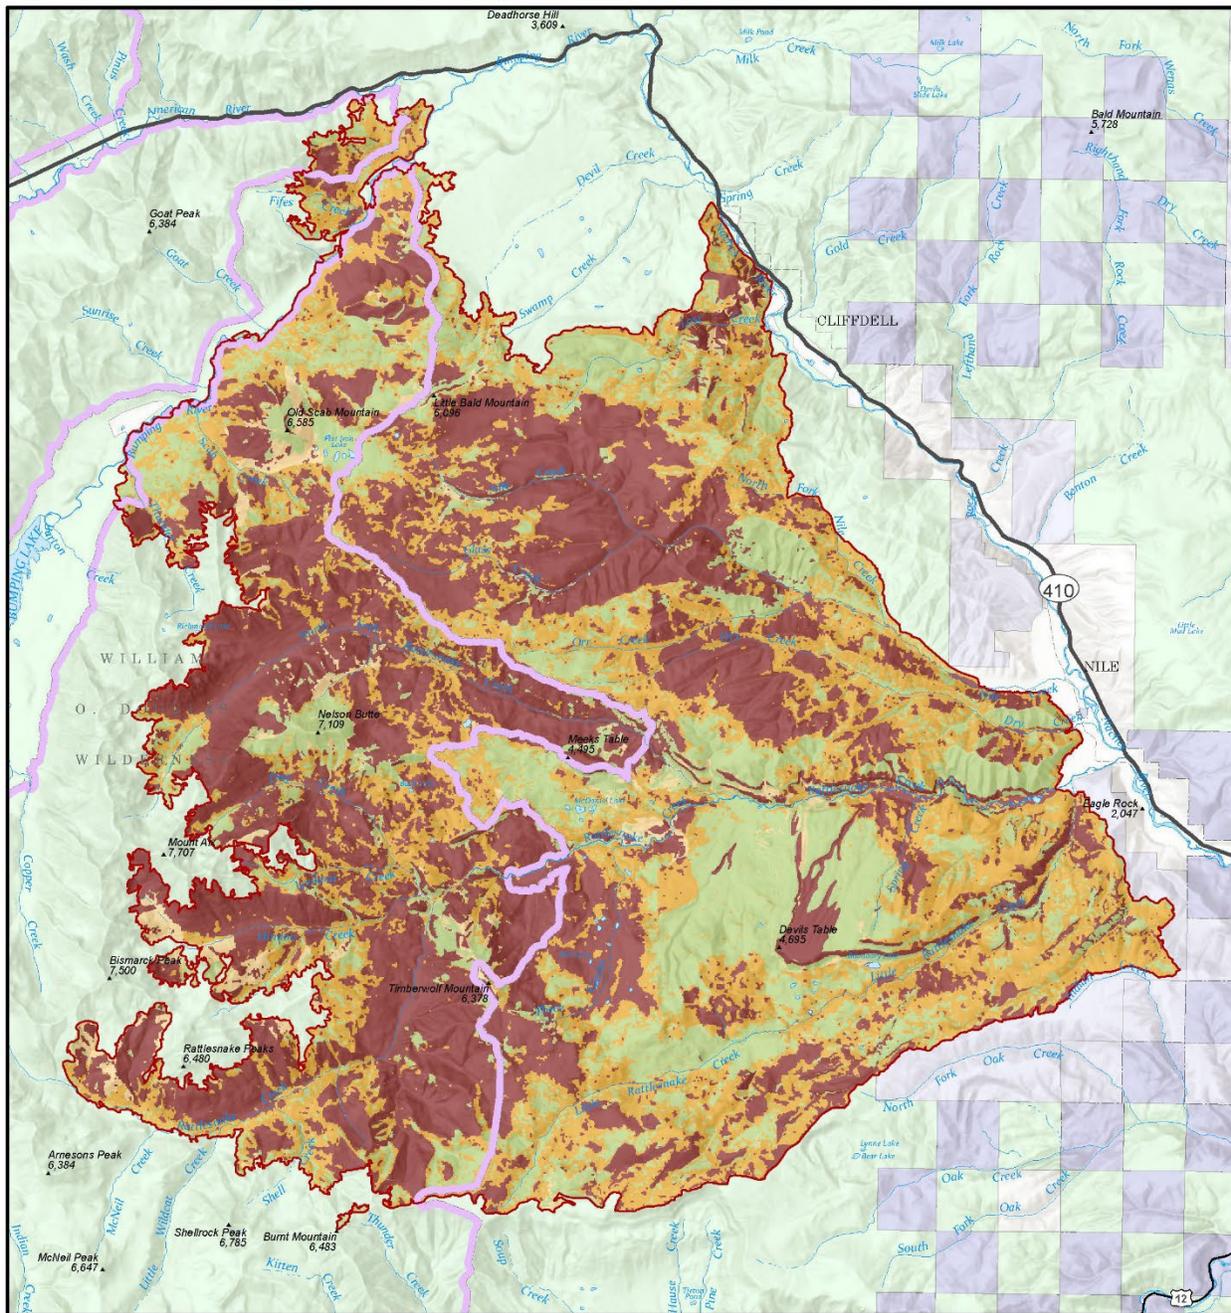
Runoff Potential Map - Schneider Springs Fire

Figure 9 Post-fire modeled runoff potential.
