# Cedar Creek Burned Area Summary

## 2500-8 Burned Area Report

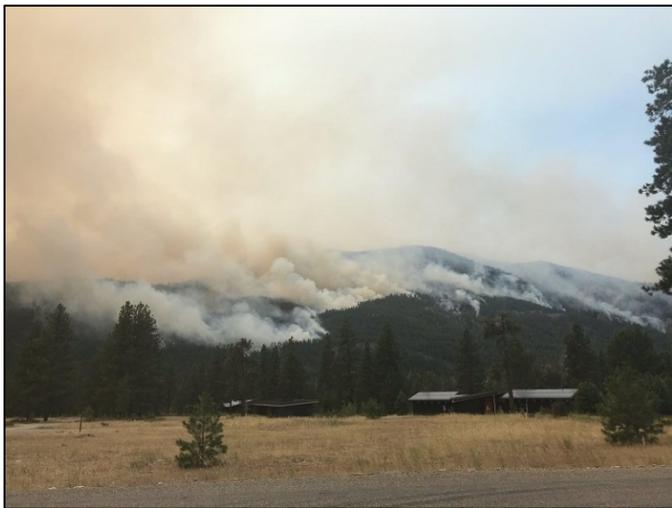
The Cedar Creek Fire started from a lightning strike on July 8, 2021. The fire started approximately 3.2 miles west-southwest of the community of Mazama, merged with the Varden Fire, and was referred to as the Cedar Creek Fire (Figure 1). This ~55,000-acre fire caused evacuations and multiple temporary closures remain in place due to the fire effects. The fire burned within the Methow River drainage. Several headwater streams within the burned area have extensive fire impacts.

Figure 1 Cedar Creek Fire activity from Goat Creek Road.
